Sketch showing present Culverts under the C.+O. RR. on the Raymond I. Wagoner Ditch No 1987 at the North line of Section 28, Lake Township, Wood County, Ohio.
June, 1946.

Martin Berry
County Engineer.

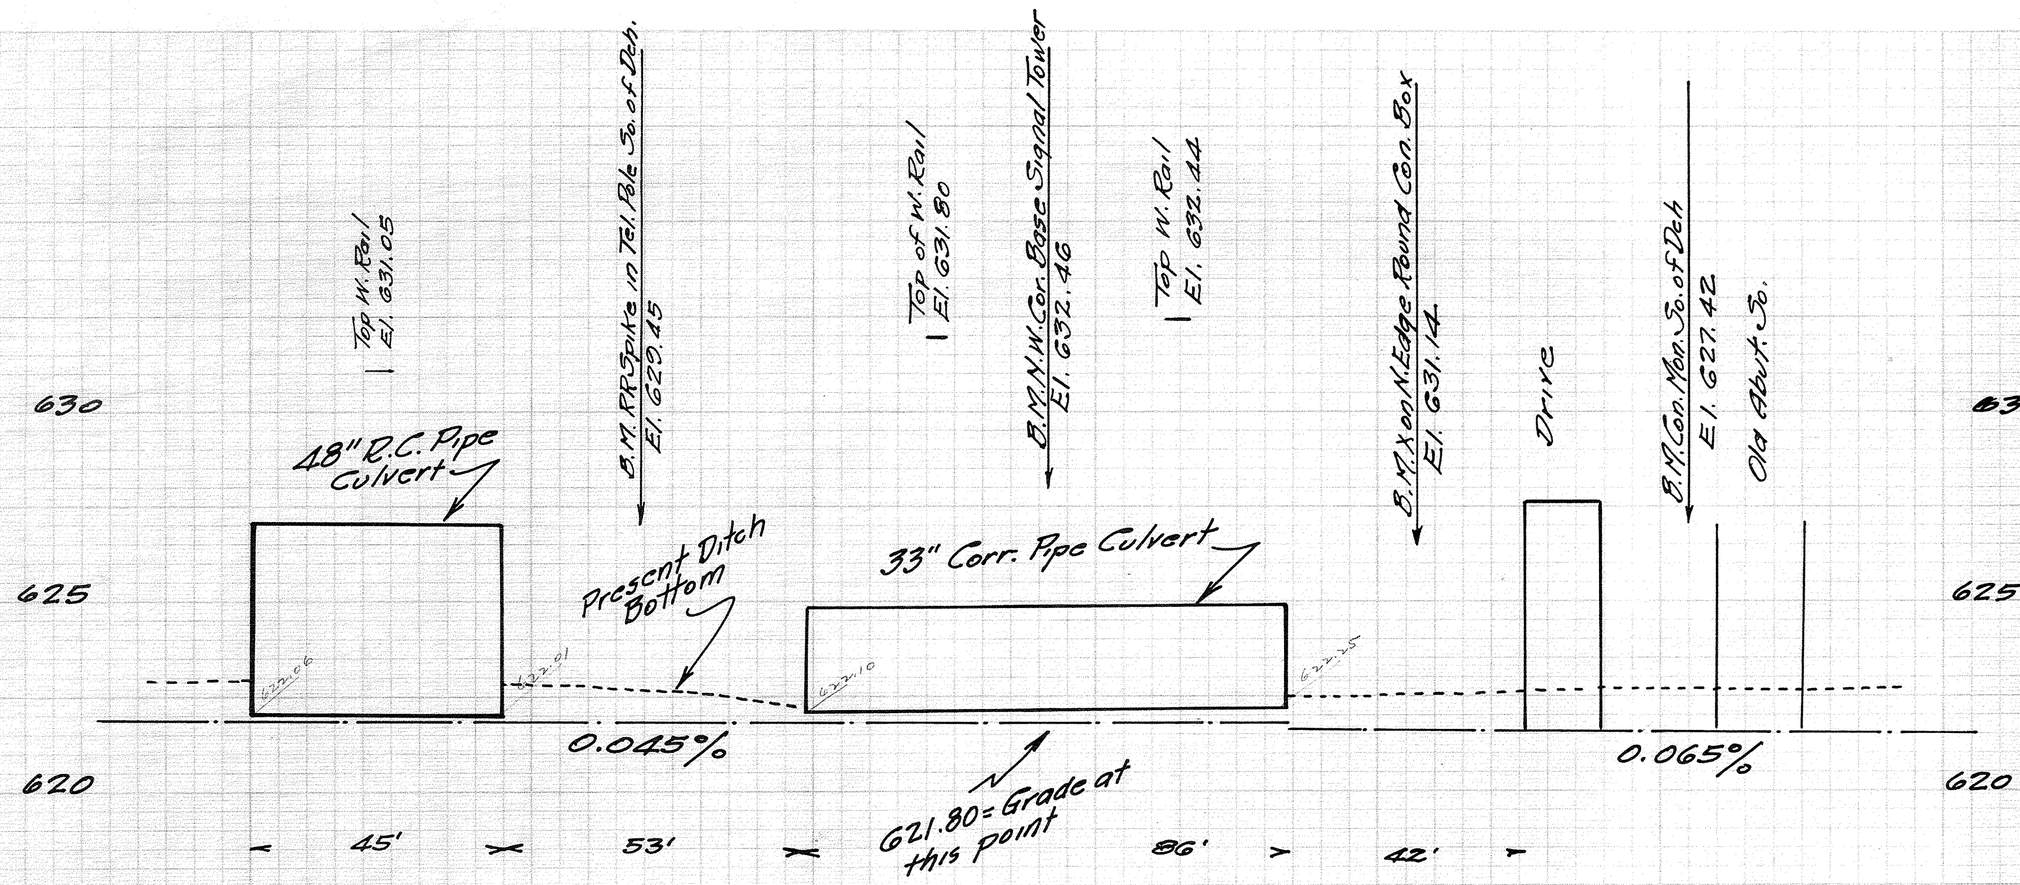
Note: Present 33" Pipe is undersized and should be replaced with a 48" Pipe or have an additional 36" Pipe installed to provide adequate capacity.
